**SCHUYLKILL RIVER BASIN
JACKSONVILLE BRANCH, ONTELAUNEE CREEK
LEHIGH COUNTY**

**PENNSYLVANIA
ID NO. PA.00787**

**LEASER LAKE DAM
(JACKSONVILLE LAKE)**

**PHASE I INSPECTION REPORT
NATIONAL DAM INSPECTION PROGRAM**

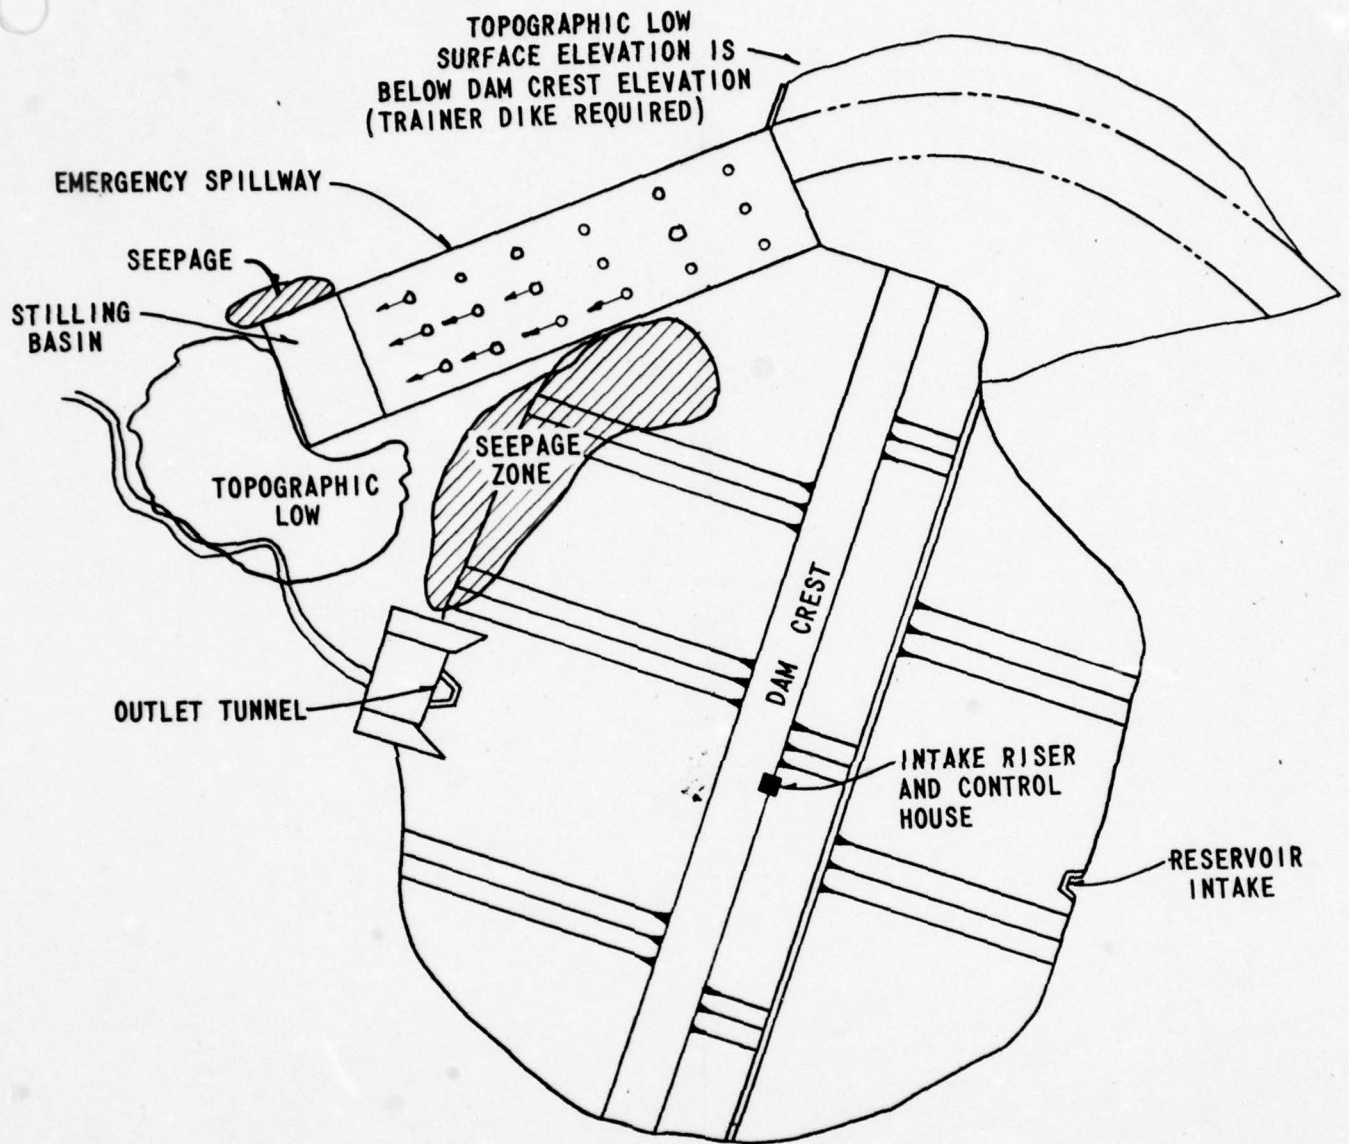
SEEPAGE LOCATION PLAN
LEASER LAKE DAM

As delineated on Sheet 5a, Appendix B, a moderate seepage volume was noticed emanating from the downstream slope near the right abutment. Initially, seepage was noted to exit the embankment as sheet flow, subsequently concentrating into several small channels as shown in Photo 8. Weep holes in the adjacent spillway were noted to be discharging clear water at approximately the same elevation as the seepage noted on the embankment slope. There was no significant distortion, misalignment or bulging of the slope observed. However, the heavy growth on the slope could be masking slight bulging of the embankment. In summary, with the exception of the embankment seepage, the embankment is functioning as designed.

As shown on Sheet 5a of Appendix B, the seepage zone extends well above the toe and covers a fairly significant area. Previous inspections by the State also reported this seepage. The first State inspection to note this was performed on 6 October 1972, by the DER, but the quantity of flow was not determined. Any changes in flow since that time were not determined. This flow was observed to be clear. The cause and future risk potential can not be properly assessed without more detailed study.

ANY NOTICEABLE SEEPAGE		Yes. See sheet 5 a. Most of the seepage was observed on the left side of the pond drain and the emergence was as high as halfway up the slope. Seepage at these same levels were observed through the chute spillway weep holes. All seepage was clear. See photographs Nos. 6 and 8.
------------------------	--	---------------------------------------------------------------------------------------------------------------------------------------------------------------------------------------------------------------------------------------------------------------------------------------

Note: Due to the type of seepage occurring (sheet flow), the quantity of flow could not be accurately estimated.

3. Further evaluation of the downstream slope seepage should be performed as soon as possible. This evaluation should include cutting the vegetation on the slope and delineating the exact extent of the seepage zone. In addition, the phreatic line should be delineated and the embankment materials investigated with regard to the causal features of the seepage emergence. Pending the results of this investigation, corrective measures should be provided to control the seepage.
4. The spalled concrete on the channels should be repaired and packed with an epoxy grout or similar material to protect the reinforcing steel.

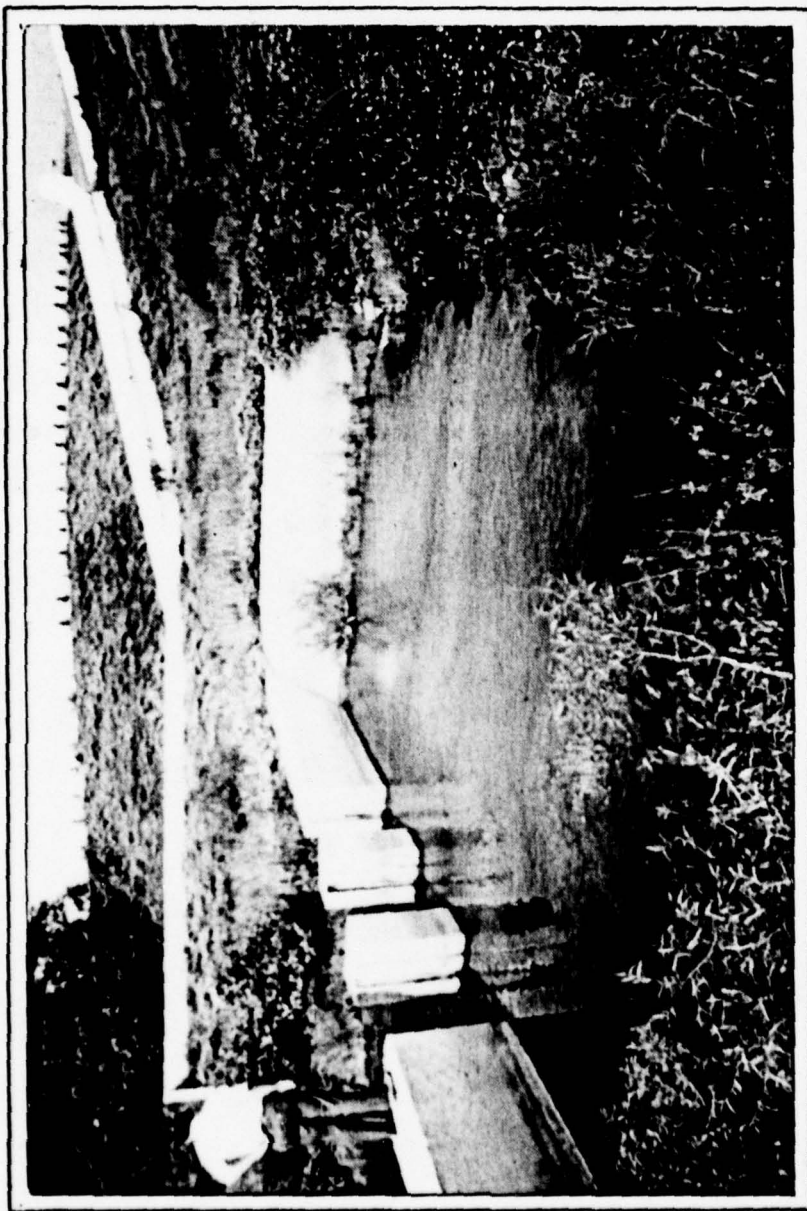
It is noted that this fish catch basin, located immediately downstream of the outlet pipe, was designed to contain stop logs and screens to contain fish which would be caught if the reservoir were drained. Mr. Stickler indicated that these screens were never installed and that the catch basin was never used as designed.

VIEW OF STILLING BASIN AT POND DRAIN OUTFALL.
NOTE COLUMNS TO HOUSE STOP LOGS FOR STILLING
BASIN.

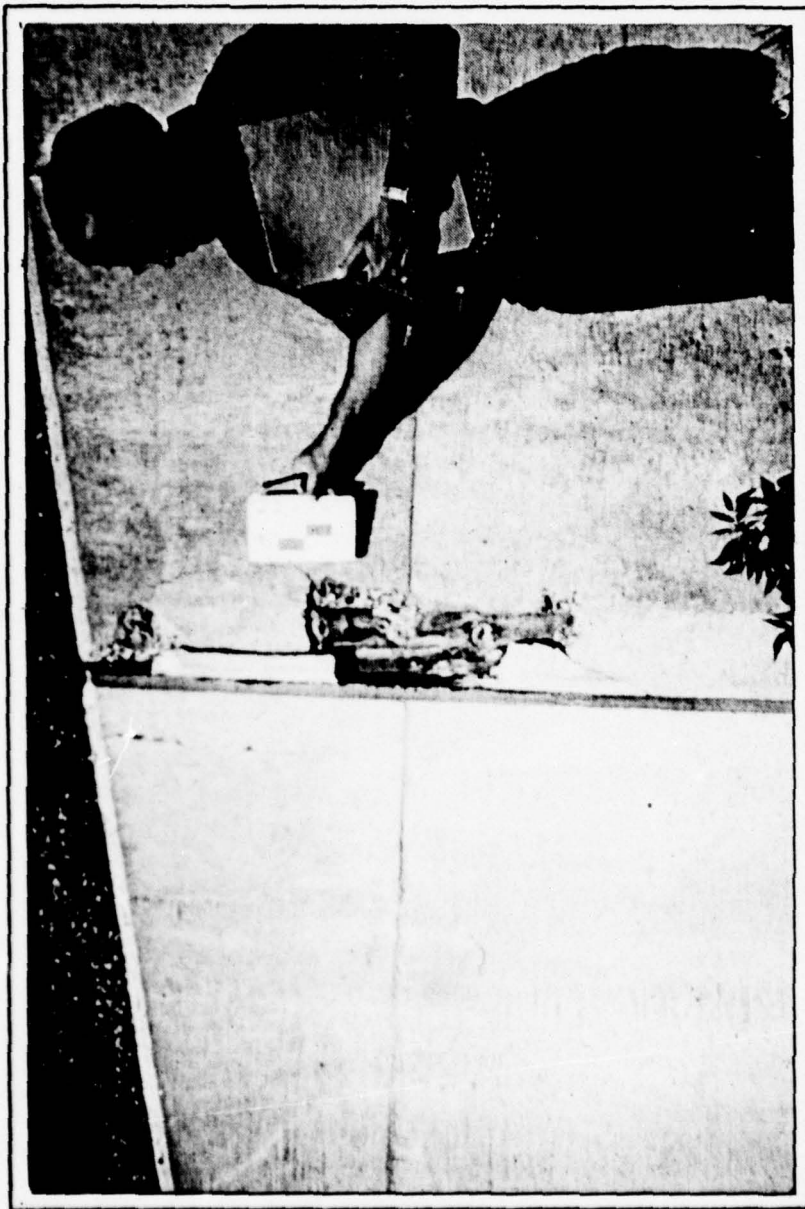
The emergency spillway was also inspected and found to be in good condition. The few spalled areas on the walls and spillway chute should be patched.

SPALLING NOTED AT SEVERAL LOCATIONS
ALONG THE INSIDE CHANNEL OF THE EMERG-
ENCY SPILLWAY. SPALLING WAS CONCENTRATED
NEAR CONSTRUCTION JOINTS.

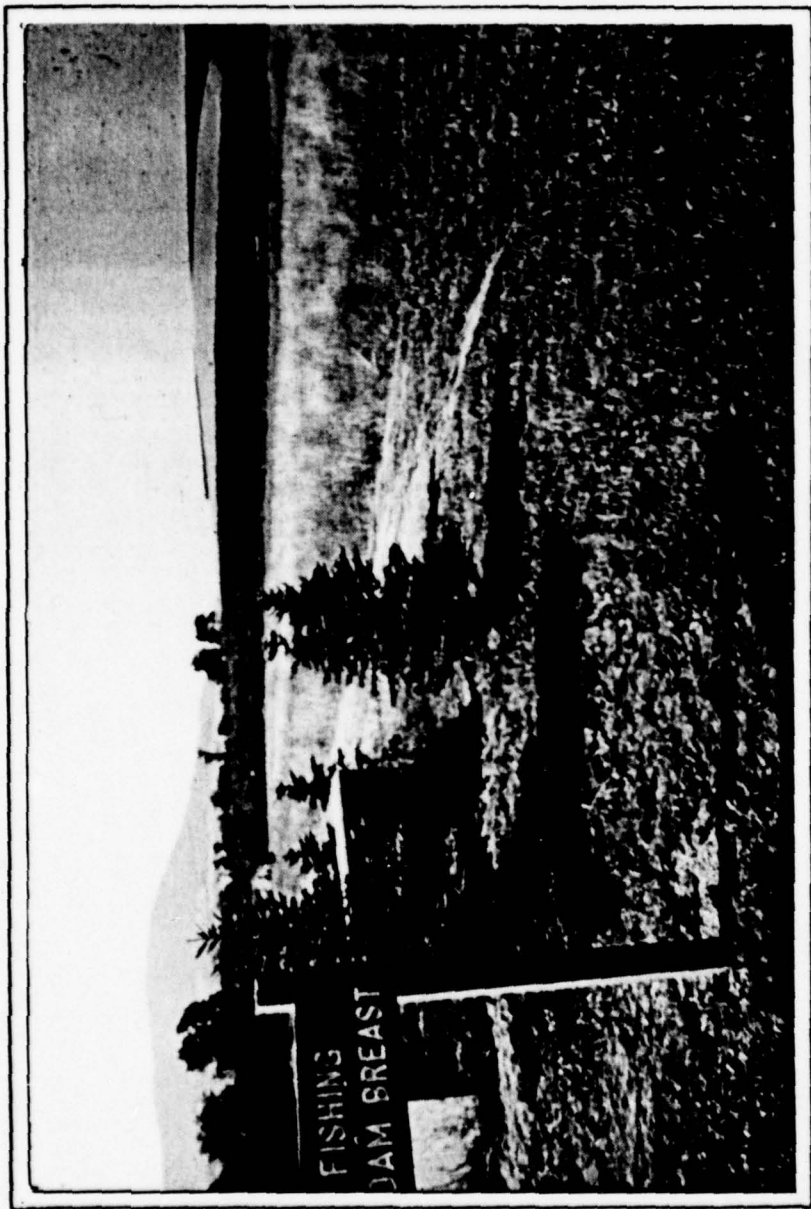
c. Visual Observations. On the date of the inspection, the only condition observed that would indicate that the outlet capacity could be reduced during a flood occurrence is that the ground surface on the right side of the spillway is about 0.8 feet below the embankment crest, thus reducing the minimum distance between the spillway crest and the minimum crest elevation. Observations regarding the condition of the downstream channel, spillway conditions, and reservoir are located in Appendix B.

The channel bottom was judged to be in good condition as well as the left side. On the right side, some bank erosion was noted which can be repaired with riprap. It is noted that the training wall on the right side is tied into the natural ground which is slightly below the dam crest. Therefore, overtopping (21 feet) would occur prior to dam overtopping. This would erode the wall on the right side. A training dike should be constructed to prevent this.

LOW AREA RIGHT OF EMERGENCY SPILLWAY
WHERE WATER WOULD PASS BEFORE OVER-
TOPPING THE DAM. FLOW WOULD TURN LEFT
BEHIND THE WALL.

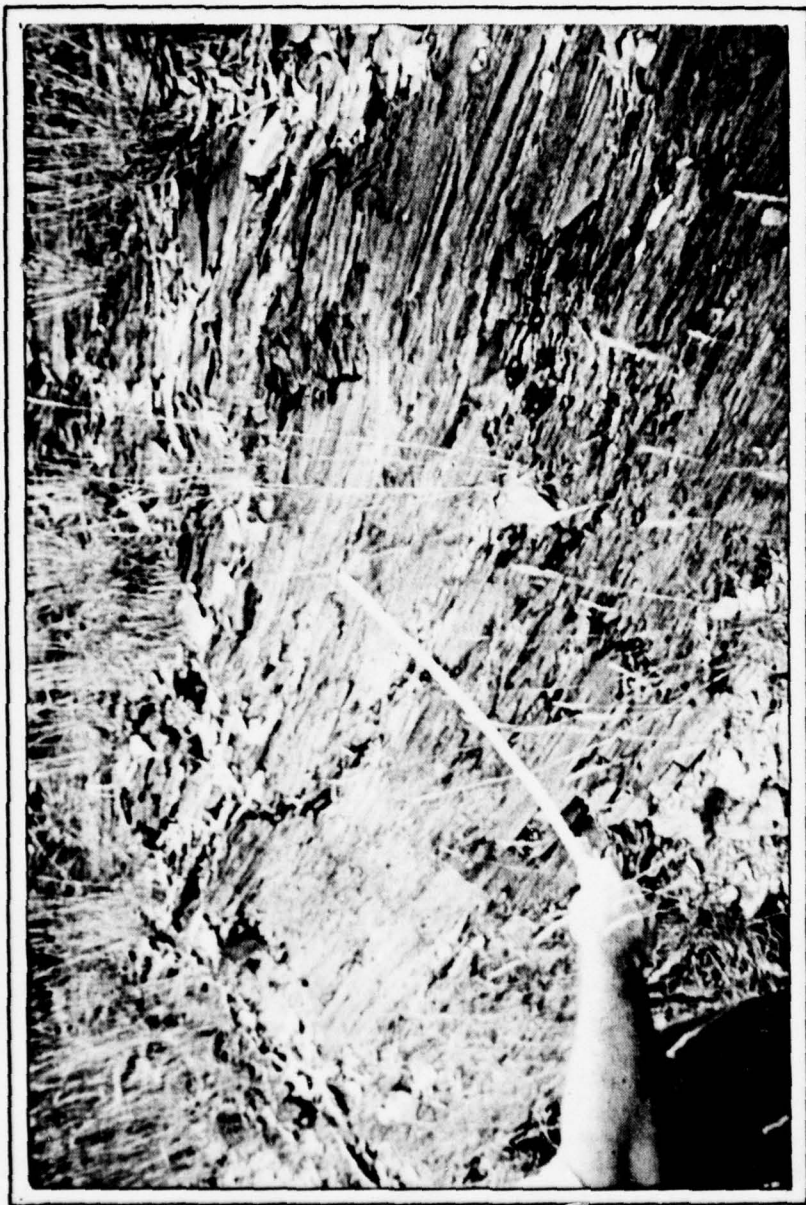
VIEW OF TYPICAL ROCK OUTCROP ON LEFT ABUT-
MENT. RESERVOIR IS TO THE LEFT OF THE
PHOTOGRAPH.
